Manhole Inspection Summary

Manhole # S23M__004MH

Insp Date: **6/17/08 1:18 PM**

Location Address: **404-S Stricker St**

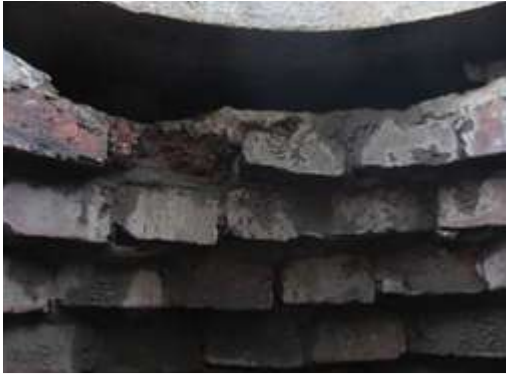
Defect 3

frame-chimney gap infiltration

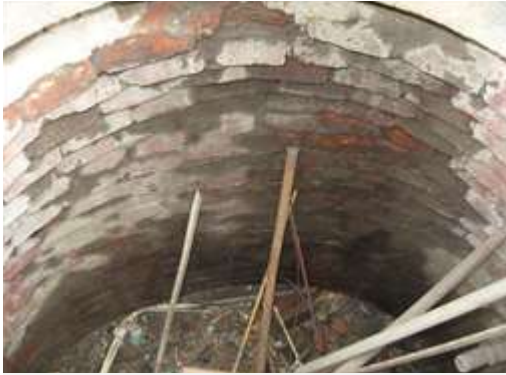
Defect 2

Infiltration: ☐ None ☒ **Joint** ☐ Cracks ☒ **Mortar** ☐ Roots ☐ Wall

Infiltration: ☐ None ☐ Joint ☐ Cracks ☐ Mortar ☐ Roots ☒ **Wall**

infiltration frame-chimney,corbel and barrel infiltration

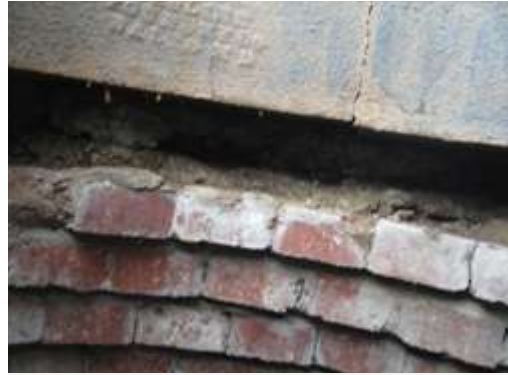
Defect 1

Frame Offset: **0** (in.) Condition: ☐ Sound ☒ **Cracked** ☒ **Leaks**

Condition: ☐ Sound ☒ **Cracked** ☐ Root Intrusion ☒ **Loose Brick** ☐ Deteriorated

Frame cracked, Gap in Chimney, Chimney Infiltration

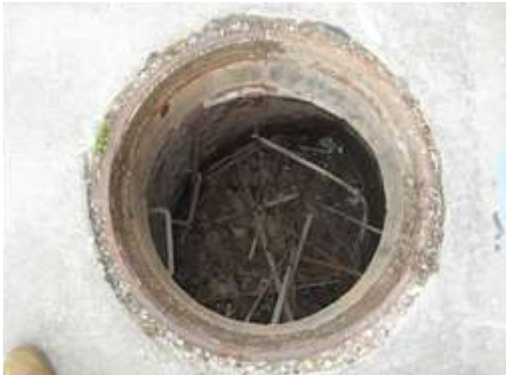
Defect 4

Condition: ☐ Sound ☐ Cracked ☐ Root Intrusion ☐ Deteriorated ☐ Leaks ☒ **Debris**

Channel Debris

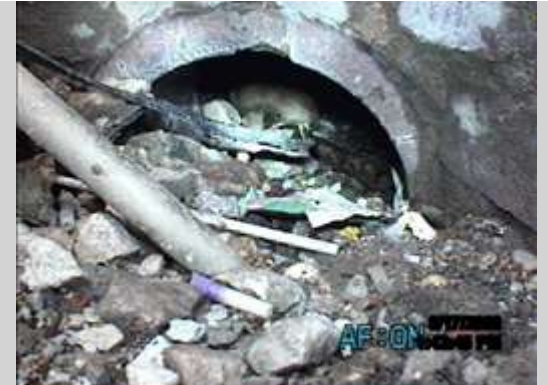
12 O'Clock Outflow

8 in. Circular Gravity Sewer
Pipe Out @ 12 O'Clock

Deposits: ☐ None ☒ **Mud** ☐ Sludge ☒ **Debris** ☐ Grease

Silt Depth: **4** (in.) Deposits Extent: **Medium**
